CRASH INJURY EVALUATION

DYNAMIC TEST OF A COMMERCIAL-TYPE PASSENGER SEAT INSTALLATION IN AN H-21 HELICOPTER

TRECOM Technical Report 63-24

DYNAMIC TEST OF A COMMERCIAL-TYPE PASSENGER
SEAT INSTALLATION IN AN H-21 HELICOPTER

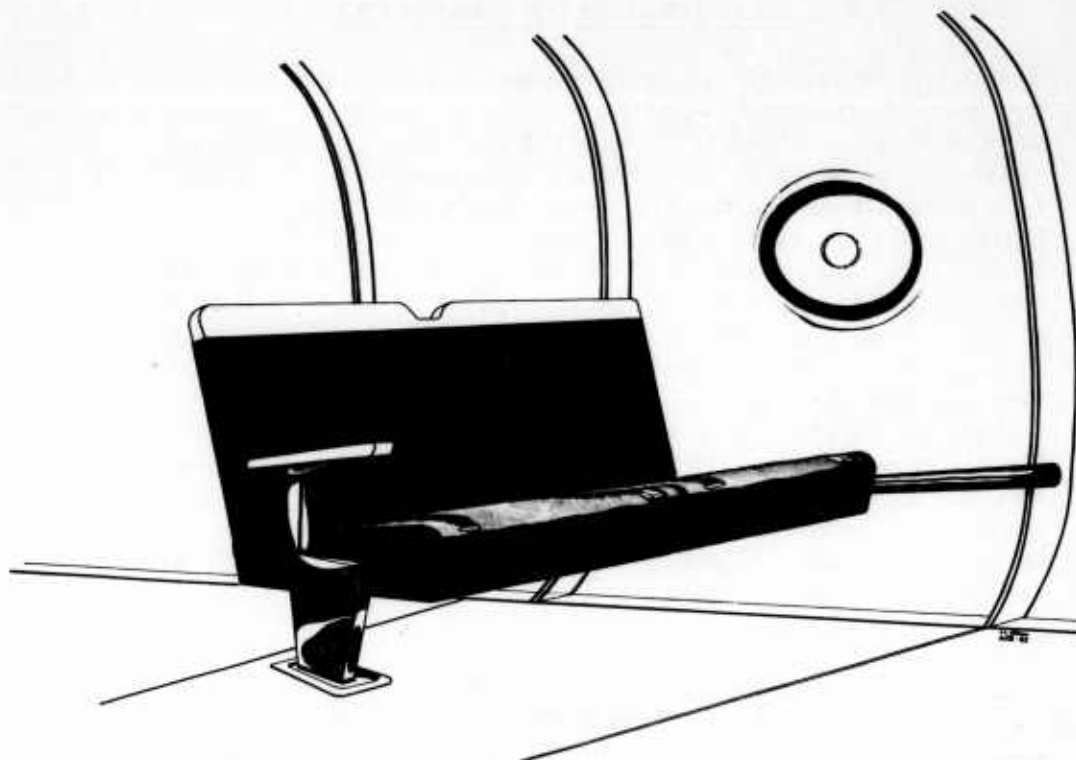
Figure 1. Sketch of Commercial Passenger Seat.

The commercial helicopter passenger seat used in this test was a two-passenger forward-facing seat. The basic structure of the seat consisted of a welded aluminum tubular frame. The frame was supported on the fuselage side by a horizontal bar attached to the fuselage wall and on the aisle side by a vertical leg. The seat was bolted to the horizontal bar by means of eyebolts to allow the seat to be folded against the wall when not in use. Individual seat-pan cushions were supplied for the occupants. These cushions consisted of a thin aluminum frame with a foam-rubber pad covered by fabric. A single back rest served both seats. The back rest folded onto the seat pan for stowage. This folding back rest provides a "break-over" feature in the event of a sudden deceleration such as a crash. The aisle support leg was bolted to the tubular structure of the seat and was designed to disconnect from the floor and fold to the bottom of the seat pan when the seat was not in use. Several sketches and photographs, including Figures 1, 2, 3, 10, 11, and 12, show this seat and the attachments.

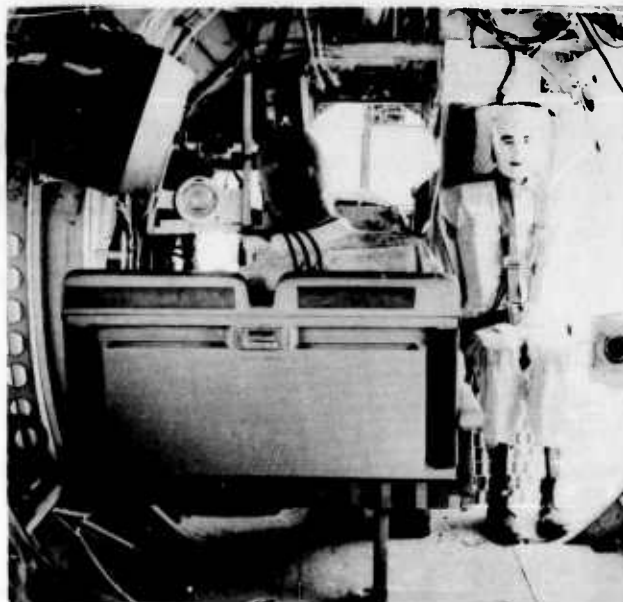
The seat was installed in the H-21 test vehicle to simulate installation in the commercial helicopter for which it was intended. Some changes were made to the H-21 structure to ensure a valid test of the seat structure proper rather than of the H-21 structure itself. These modifications, described below, must be considered when extrapolating the performance of the seat as reported to other installations. The normal wall attachments of the seat were connected to a 1-1/4-inch O. D. tube which was, in turn, attached to the basic aircraft structure. The use of similar tubes as a means of connecting seats to the airframe has been widely practiced by the military. These tubes, normally of aluminum, have proved to be a weak point during a crash due to insufficient strength in the vicinity of points where holes have been drilled for attachment to the airframe and attachment of seat belts. Consequently, to ensure that the commercial helicopter would be given a valid test, the conventional aluminum tube in the H-21 was replaced by one of 4130 steel. Figure 2 shows a rear view of the commercial passenger seat as installed in the H-21.

The leg on the aisle side of the seat was connected to a plate on the floor and incorporated a quick disconnect to facilitate folding of the seat. The plate itself was made of two metal flanges bolted together through the honeycomb floor. This can be seen in Figure 2. The installation was similar to that proposed for in-service aircraft.

Figure 2. Rear View of Commercial Passenger Seat, Installed.
Arrow shows 1-1/4-inch O. D. x 0.125-inch wall SAE
4130 tube used for support of outboard end of seat.

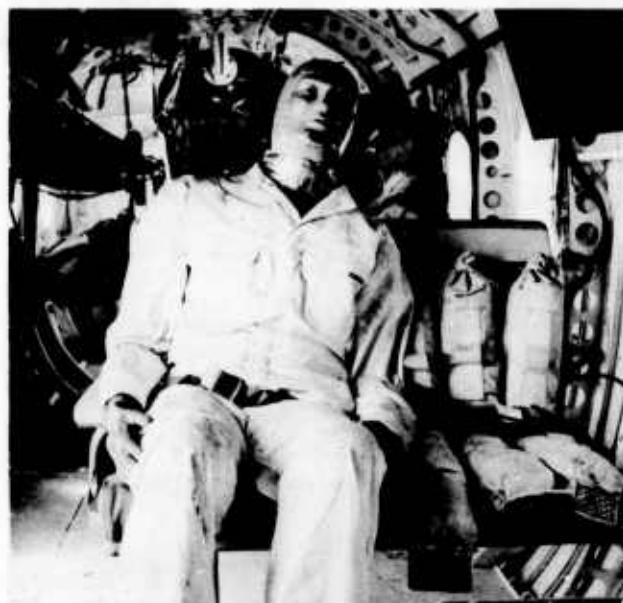
Figure 3 shows the seat installed. The dummy on the aisle seat was a 95th percentile anthropomorphic dummy. The wall seat was occupied by three sandbags designed specifically for this application. They were 4-inch diameter cylinders, 36 inches long, each filled to 40 pounds. The 120 pounds was chosen only to simulate a lighter passenger in the wall seat.

Figure 3. Front View of Seat, Showing Anthropomorphic
Dummy and Sandbags.

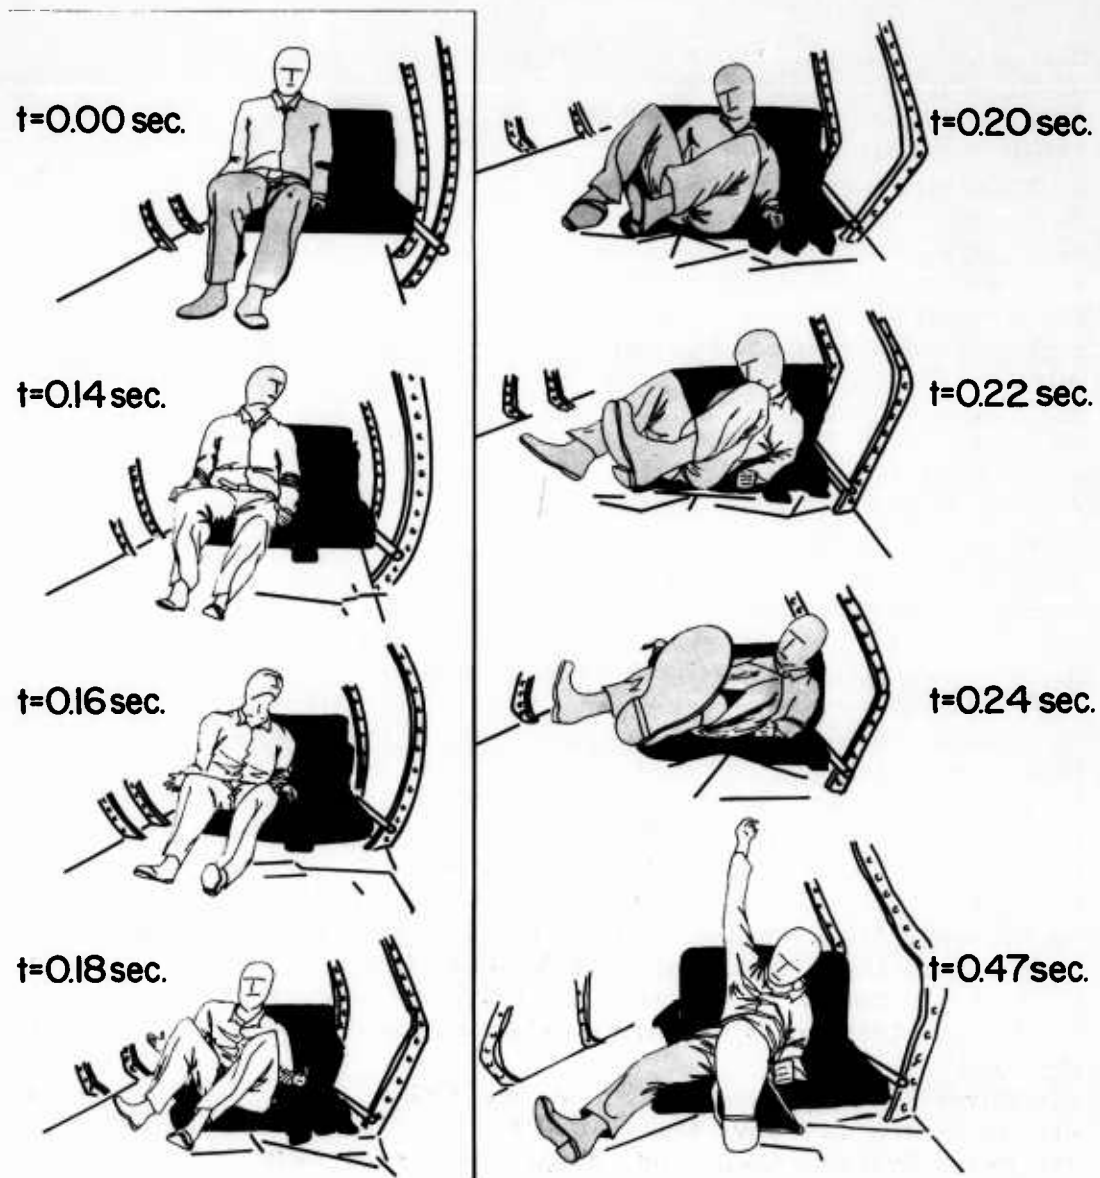
Figure 17. Kinematic Sketch of Seat and Dummy.

Observation of high-speed films from on-board cameras shows, as noted in Figure 16C, that during this interval the floor in the vicinity of the seat underwent the deformation shown in Figures 10 and 11, and that the dummy seat and dummy itself (Figure 17) underwent maximum displacement. Two separate pulses are evident in Figure 16C, i. e., a half sine wave in the interval from 0.15 to 0.19 second, followed by a smaller pulse at 0.21 second. An average of about 33G was maintained for some 0.025 second, accounting for a change in velocity of about 26 feet per second. The recorded "vertical" pulse would have probably been somewhat greater had the dummy remained truly vertical throughout the impact. The recorded "lateral" and "longitudinal" accelerations were more of an oscillatory nature, as seen in Figures 16A and B.
